Cause of Damage and Failures in Silo Structures

Abstract: Silos are special structures subjected to many different unconventional loading conditions, which result in unusual failure modes. Failure of a silo can be devastating as it can result in loss of the container, contamination of the material it contains, loss of material, cleanup, replacement costs, environmental damage, and possible injury or loss of life. Silo damage and failures that occurred in different regions of the world are presented in the paper using illustrative photos. Also provided are a review and discussion of the common or spectacular silo failures due to explosion and bursting, asymmetrical loads created during filling or discharging, large and nonuniform soil pressure, corrosion of metal silos, deterioration of concrete silos due to silage acids, internal structural collapse, and thermal ratcheting. Silo damage and failures from several earthquakes are also presented.

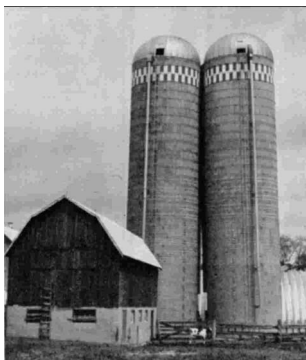
The soil underneath the two adjacent grain silos built in the Red River Valley in Canada did not have sufficient strength to resist the applied gravity loads (Fig. 5). Bozozuk (1972, 1976) reported that the silos were built on Lake Agassiz clay and were too close so that the “pressure bulbs” under the foundations overlapped. This caused larger stresses and, in turn, larger settlements under the parts of the ring foundations where they were closer to each other. The end result was tilting, touching, and eventual structural failure of the silos. If a group of bins are constructed together to form a cellular structure, there is a potential for the individual stress bulbs to overlap in the two orthogonal directions. Consequently, the ground is exposed to amplified stresses in a larger area under the silo structure. In 1913, the group of 65 grain bins shown in Fig. 6 started to tip over. The newly built silo was loaded with over 1 million bushels of wheat. The structure con-

Fig. 5. Leaning twin silos due to nonuniform settlement in zone of overlapping pressure bulbs (Bozozuk 1976, ASCE)

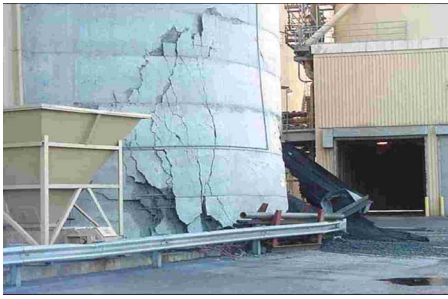
In 2001, the base of a 18 m diameter silo became unstable and one employee died due to partial collapse of a structure inside the silo (Fig. 8). The top two thirds of the silo had 1,400 t of coal and the bottom third contained equipment for crushing and blending coal before it is fed onto a conveyor and sent to the plant’s boiler. The silo was used to store and blend coal for use in the power station’s 66-MW fluidized bed generating unit. The employee was believed to have been in his work area in the bottom of the silo when the coal and machinery plummeted to the bottom after the internal structure collapsed (Kazas 2001). This accident shows that for life safety, whenever possible, the machinery and employees should not be inside a silo while the bulk material is stored in the upper portions of the silo.

Fig. 8. View of external damage at MEA coal silo (Kazas 2001, with permission from Morgantown Energy Associates Plant)

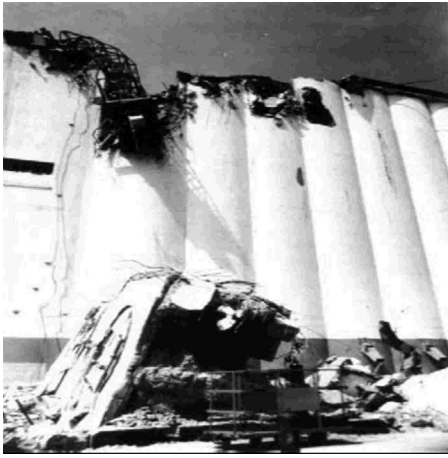
The 8.1 magnitude earthquake occurred 80 km southwest of Lima. The tremor killed 78 and injured several thousand people. During this earthquake, a large grain elevator in the port area of Callao lost its headhouse which fell from the tops of the silos and embedded itself in the adjoining pier (Fig. 11). It was reported that this elevator suffered damage earlier in the 1970 Peru earthquake and was considered unsafe (Moran et al. 1975). This is

Fig. 11. Partial collapse of grain silo during 1974 Lima, Peru earthquake (USGS 1974)

a good example of silo damage resulting from failure of a secondary structure or machinery improperly attached to the silo structure.

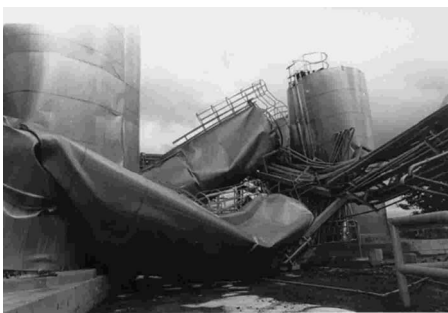
The earthquake that struck Edgecumbe, New Zealand on March 2, 1987 had a magnitude of 6.1 and a focal depth of 6 km. This was one of the strongest and most damaging earthquakes to hit New Zealand in recent history. At Bay Milk Products facility in Edgecumbe, huge stainless steel milk silos collapsed, spilling thousands of liters of milk. Two milk storage tanks were thrown on their sides, as shown in Fig. 12.

Fig. 12. Collapse of stainless steel milk silos during 1987 Edgecumbe, New Zealand earthquake (CAE 2007, with permission)

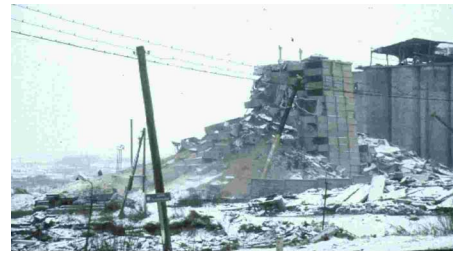
On December 7, 1988, at 11:41 a.m. local time, a magnitude 6.9 earthquake shook northwestern Armenia. Fig. 13 shows the east end of the granary in the flour mill complex east of Spitak. Grain can be seen spilling out of the collapsed concrete shear-wall structures in the foreground. In the background are cast-in-place concrete grain silos. Most such silos had no or only minor damage during the earthquake. However, overall losses at the flour mill complex were large (NGDC 1988). It should be noted the silo structure that failed during this earthquake was noncylindrical, however its height was comparable to that of the nearby undamaged cylindrical silos.

Fig. 13. Damaged grain storage complex and spilled out grains due to 1988 Spitak, Armenia earthquake (Photograph by C. J. Langer; JAMA 2007)

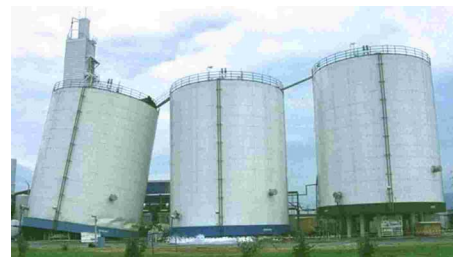
Fig. 14. Silos collapsed during 1999 Duzce, Turkey earthquake: (a) Xiao and Yaprak (1999); (b) GESS (1999) (Courtesy of J. P. Bardet, University of Southern California); and (c) undamaged liquefied nitrogen tank (on right) and two liquefied oxygen tanks damaged during 1999 Kocaeli, Turkey earthquake

During the 1999 Kocaeli earthquake, two of the three above-ground tanks collapsed as a result of failure of reinforced concrete columns supporting the tanks [Fig. 14(c)]. The collapsed tanks contained liquefied oxygen and were 85% full, and the undamaged liquefied nitrogen tank was 25% full at the time of the earthquake. It is estimated that approximately 1,200 metric tons of cryogenic liquefied oxygen were released as a result of collapse of the two oxygen storage tanks. The liquefied nitrogen tank next to the collapsed tanks was virtually undamaged. Based on the detailed dynamic analyses of the tanks, Sezen et al. (2008) concluded that the sloshing of the stored fluid did not affect the tank response significantly, and the failure was mainly due to insufficient strength and deformation capacity of the columns supporting the oxygen tanks. They also concluded that if an elevated tank is desired in a seismic region, the strength and deformation capacity of the support columns should be increased considerably, or an alternative support structure should be used.
